## Surface Coating Loss on Scleral Lens

Category(ies): [Contact Lens](#)

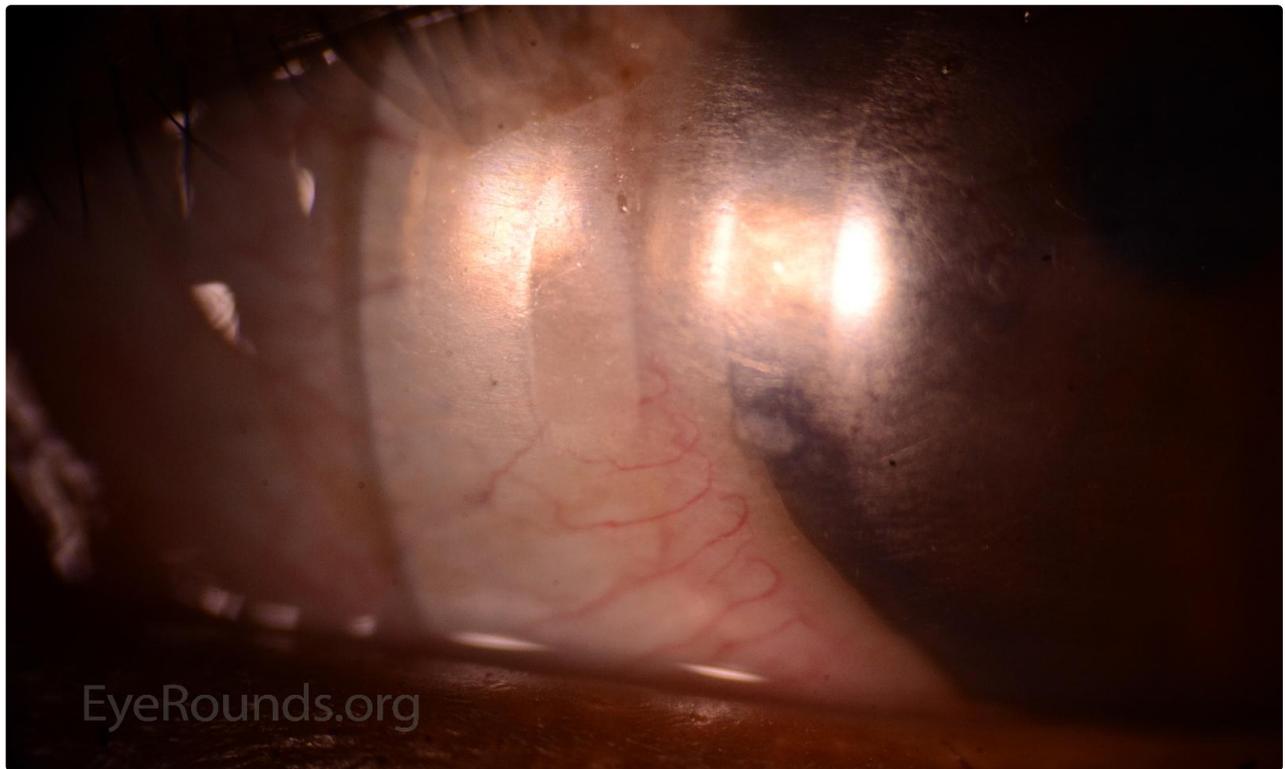
Inappropriate cleaners, excessive rubbing, cosmetic supplies, and the long-term result of cleaning appropriately will eventually strip the surface coating off of any lens.
